# The Windows Have It

## Architectural Elements

Article and Photographs by ZoAnn Campana,  
Architectural Historian

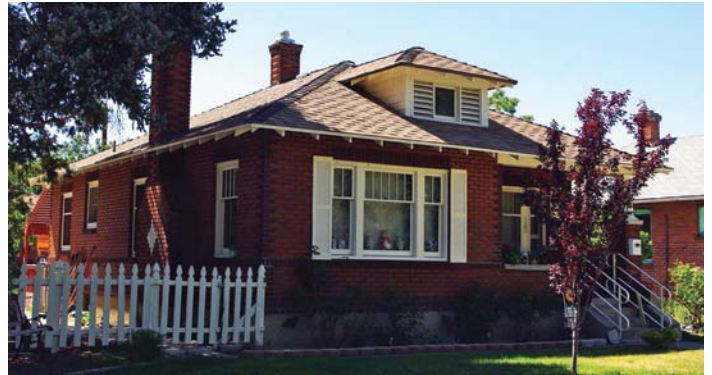
This Craftsman style cottage retains its original wood windows with divided upper lights, often referred to as "Craftsman windows."

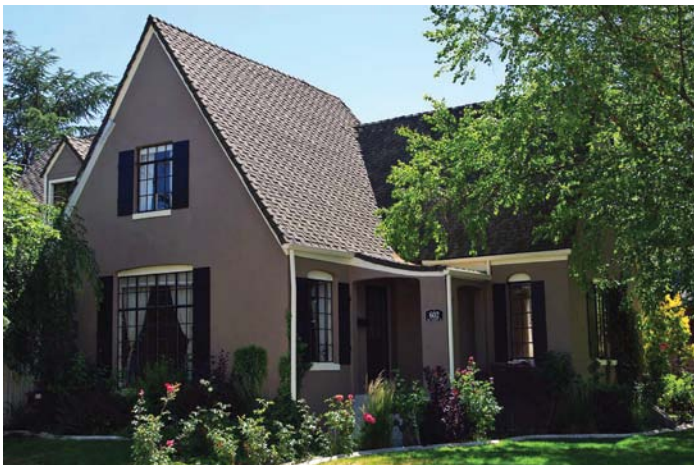
This Tudor Revival house retains its original metal casement windows.

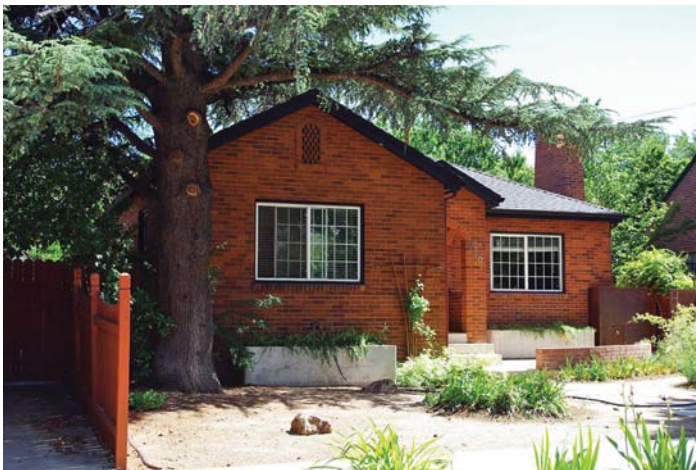
This Period Revival cottage's original metal casement windows have been replaced with vinyl sliders with prefabricated grids to resemble muntins. Note the flat profile of the window and its components compared to the deeper profiles seen in historic windows.

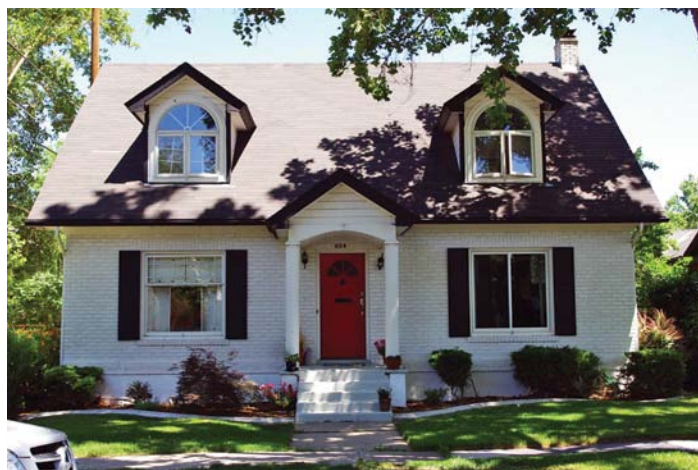
This Colonial Revival cottage retains one historic window in its facade. It is the wooden "Craftsman" window with divide upper lights on the left side of the first story. The other first-story window has been replaced with a vinyl slider, and the dormer windows have been replaced with vinyl casements and fanlights.

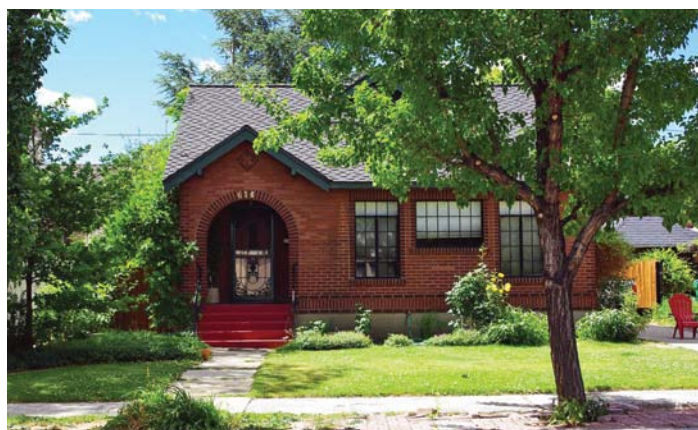
This Period Revival cottage retains its original metal casement windows.
